Autonomous Soaring 2005 Flight Data Summary

Flight testing of the 14ft span CloudSwift UAV was conducted during the summer of 2005. Test maneuvers included aircraft checkout, Piccolo gain tuning, FTS range tests, and thermal soaring research flights. A description of each flight is given in table 1.

2006 Autonomous Soaring Project Flight Data Summary

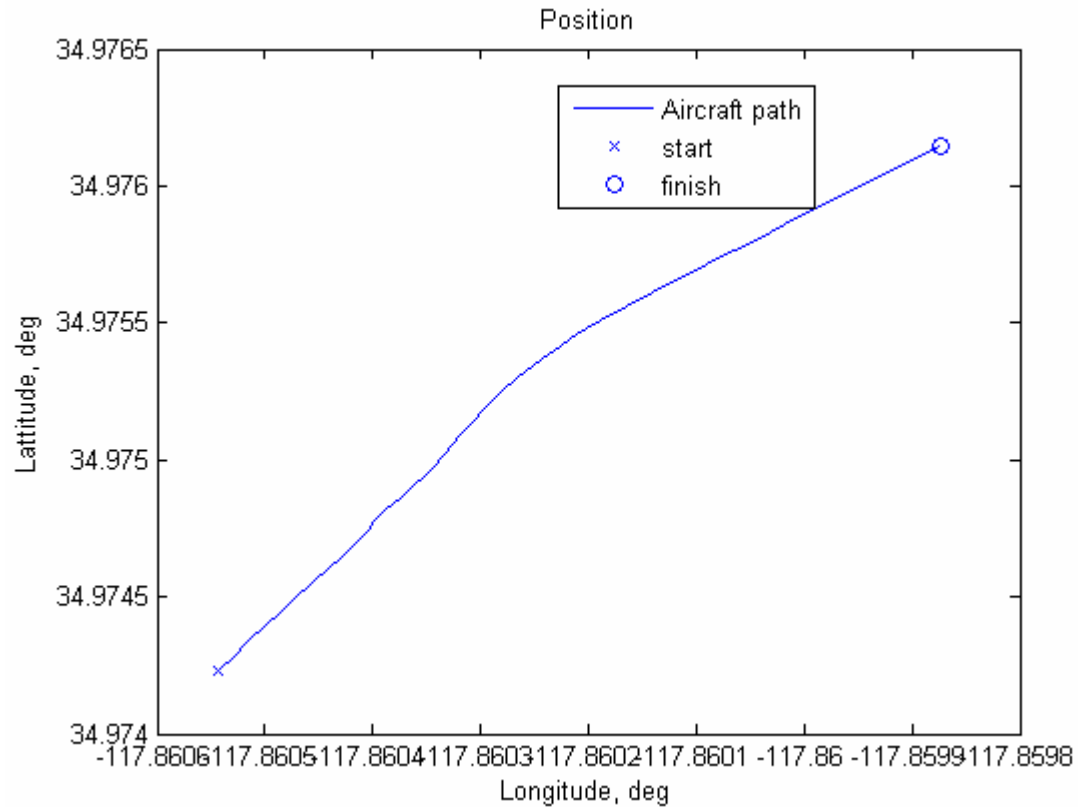
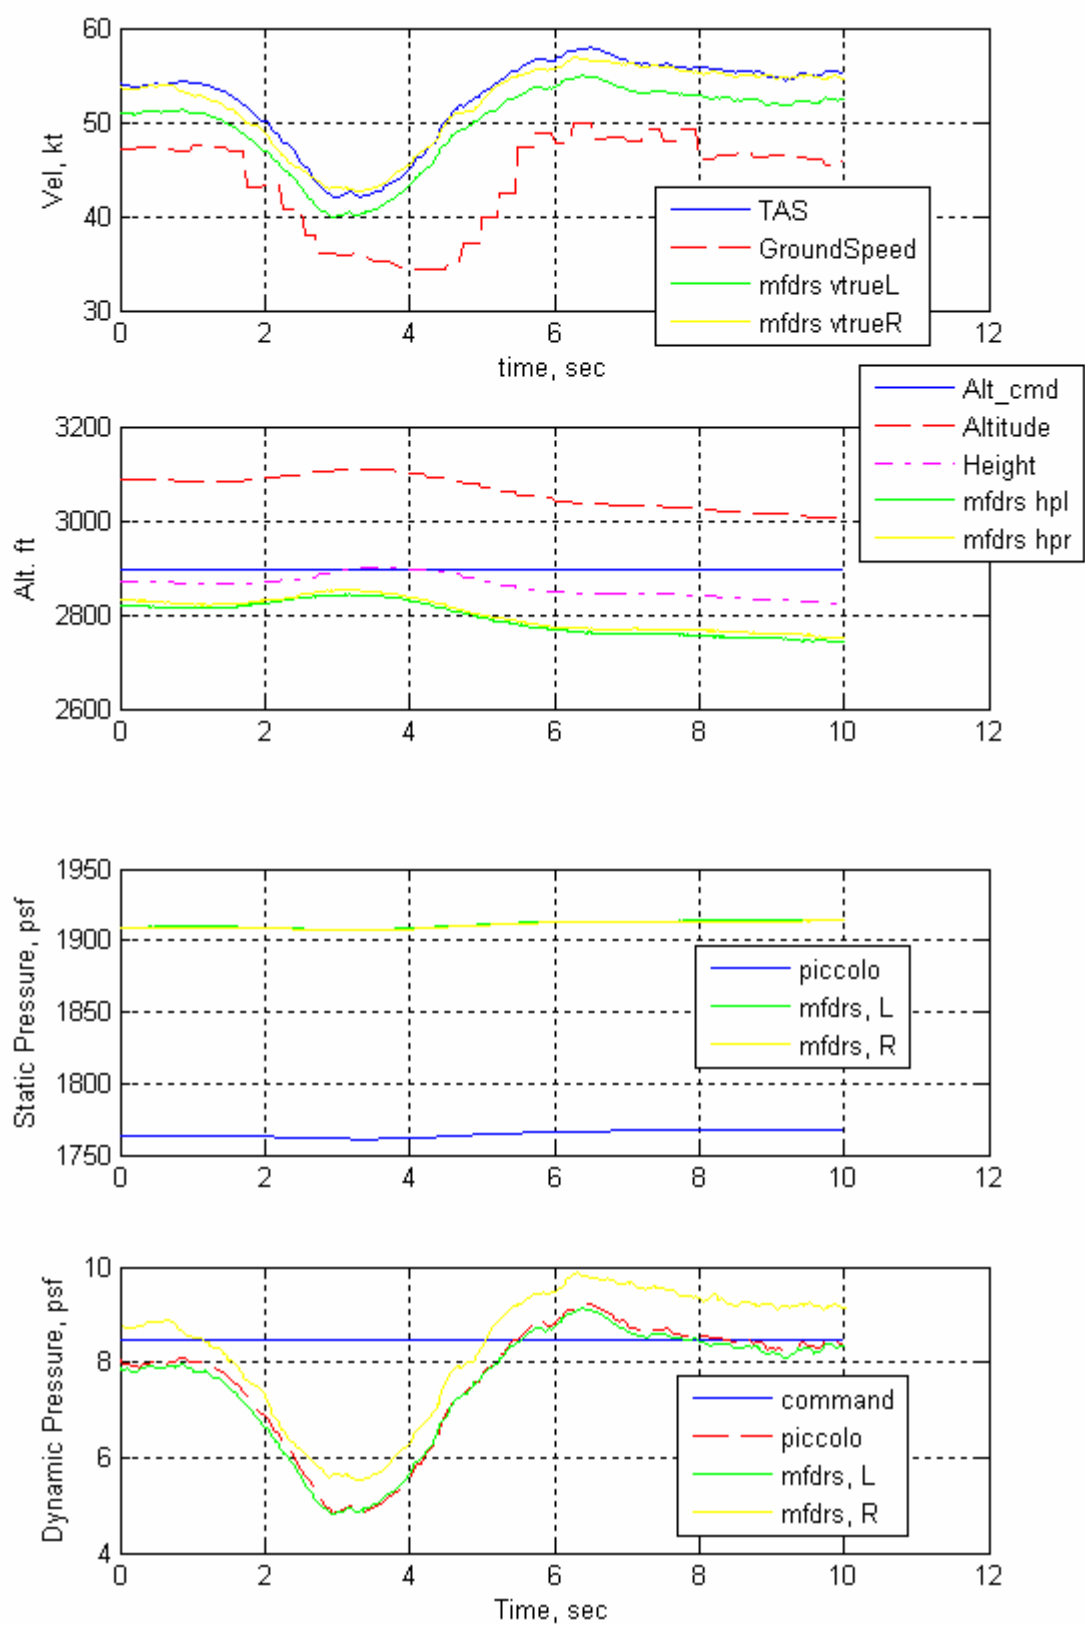
1.4.10 Elevator Doublet 3 (55kt)

This extremely large doublet was done at the start of the 55kt glide. The doublet was incorrectly set to start at zero instead of the trim position. The airplane did not stay on condition. Throttle was not zero for this doublet.

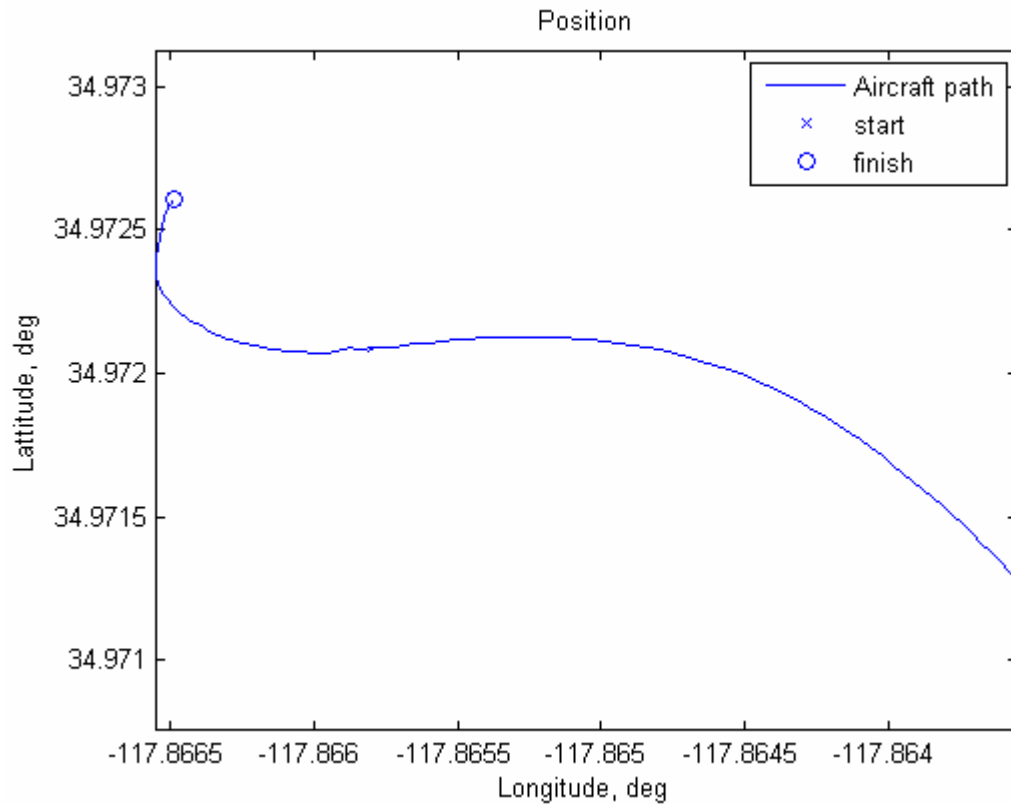
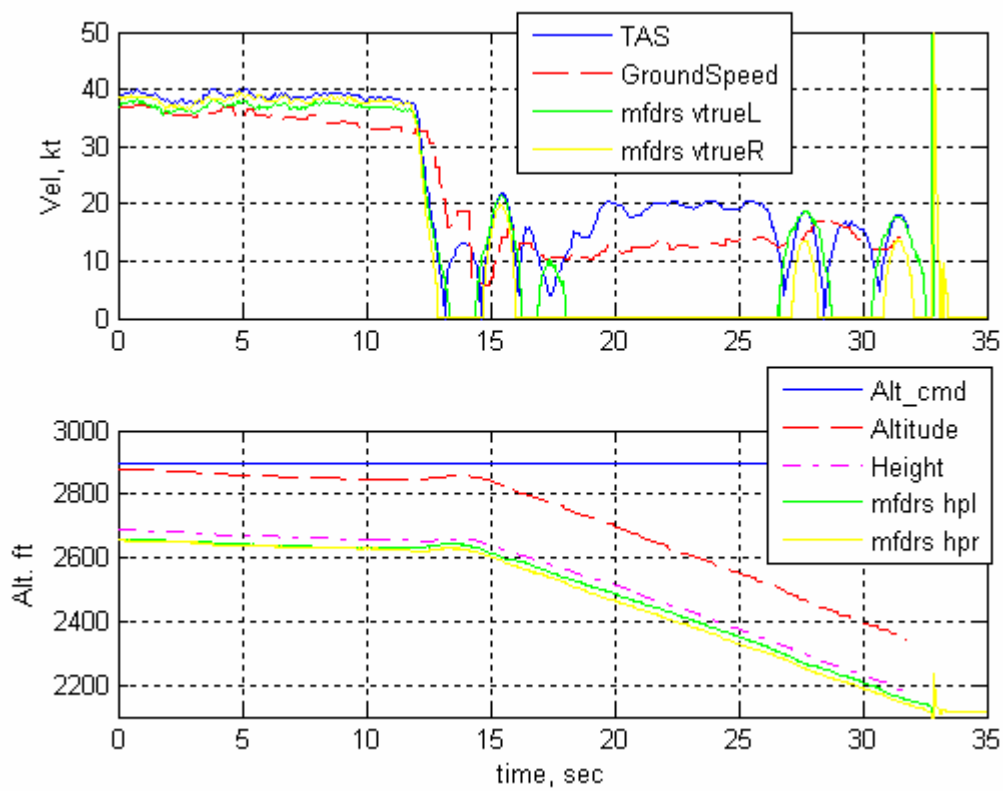
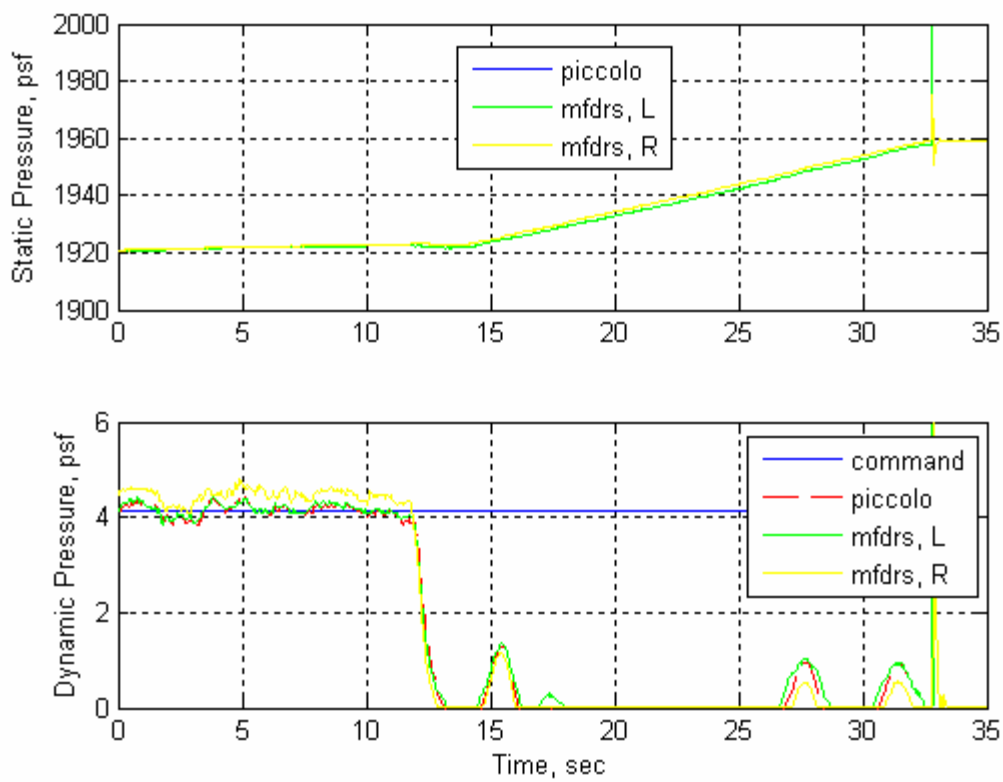
1.6.9 FTS deployment

Flight 3 was ended when the aircraft FTS self-deployed. Luckily, the MFDRS was recording during the event. The FTS on this aircraft moves the full-flying horizontal tail to approximately 60deg trailing edge up, causing a deep stall condition. The calibrations for angle of attack, sideslip angle, and elevator position are not valid during the deep stall. The pilot increased the throttle during the descent for a few seconds then returned the throttle to zero

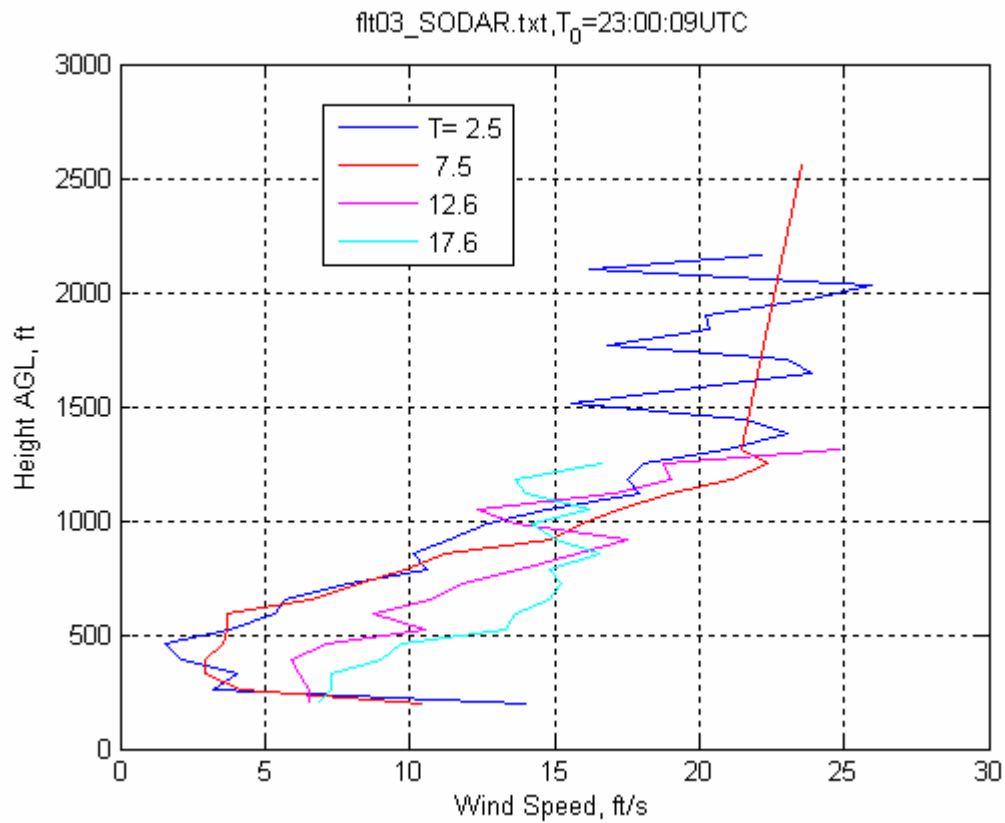
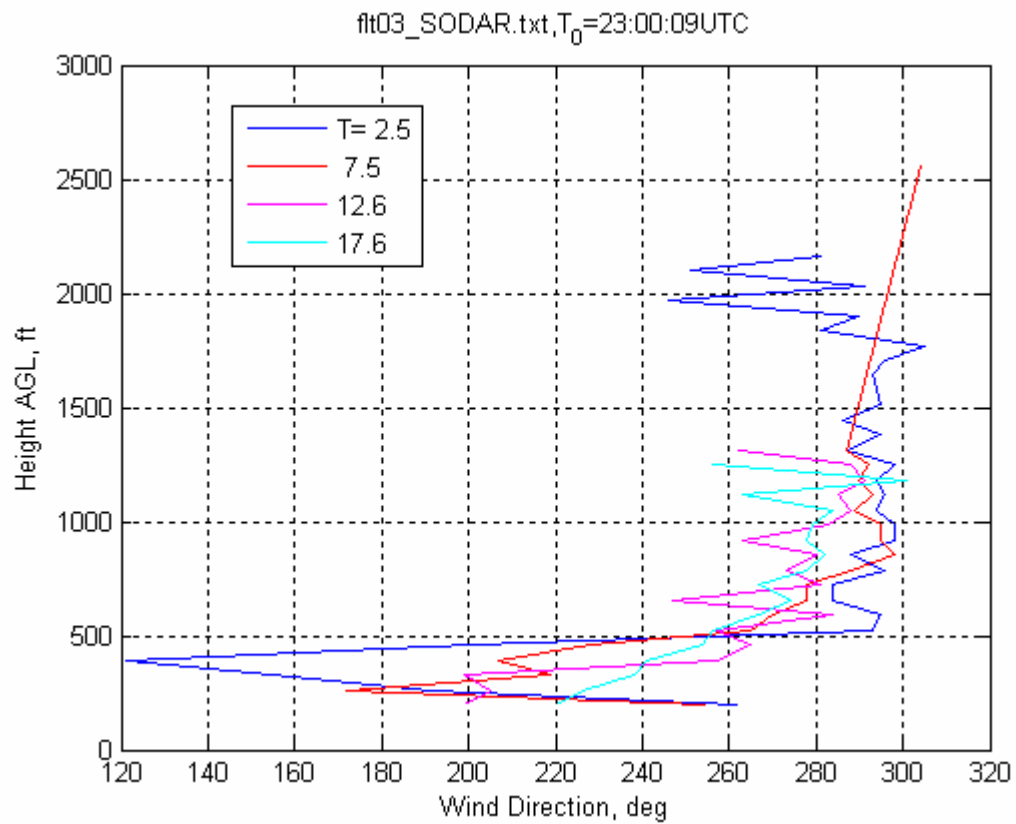
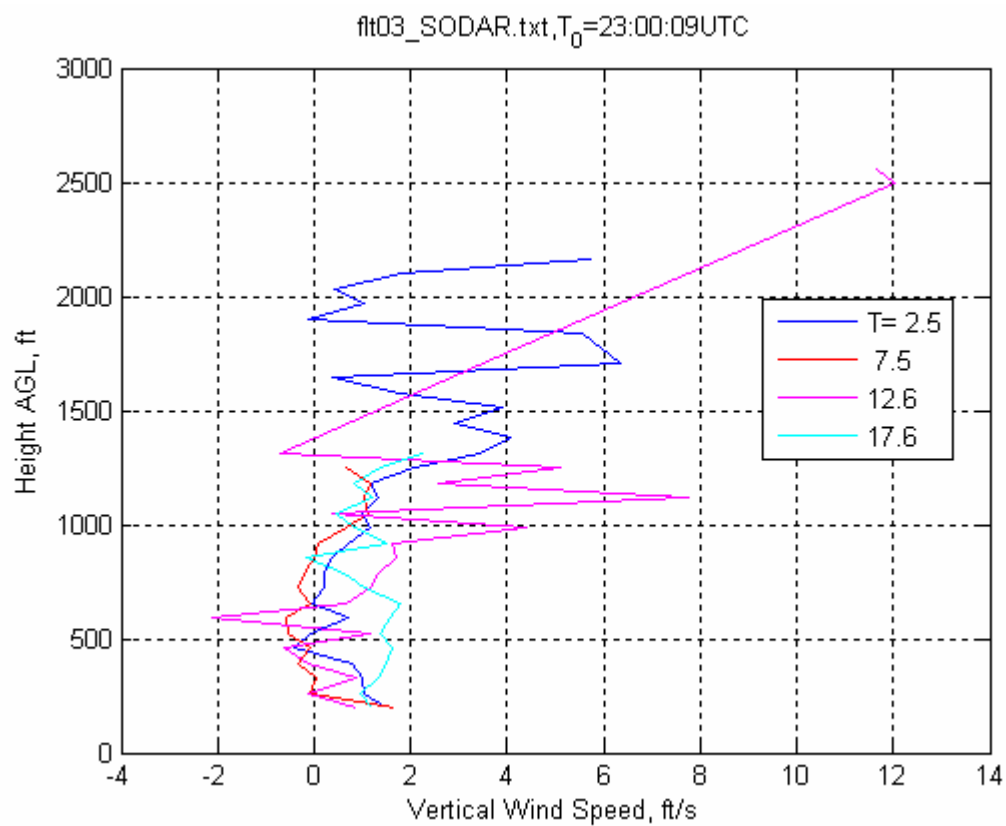
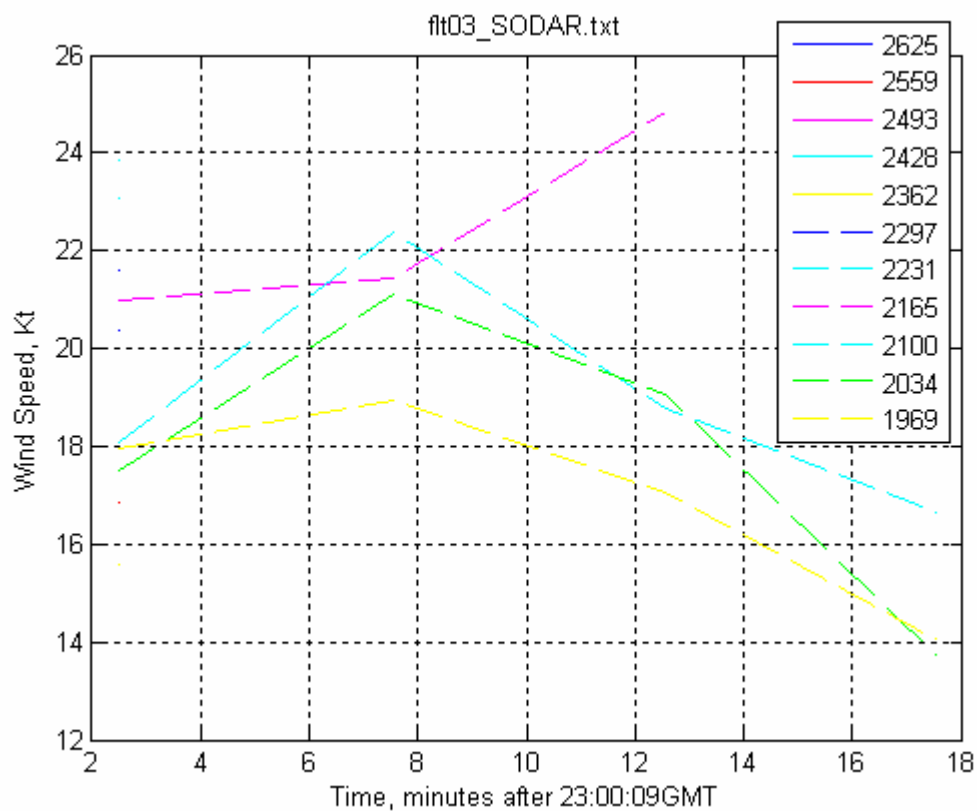
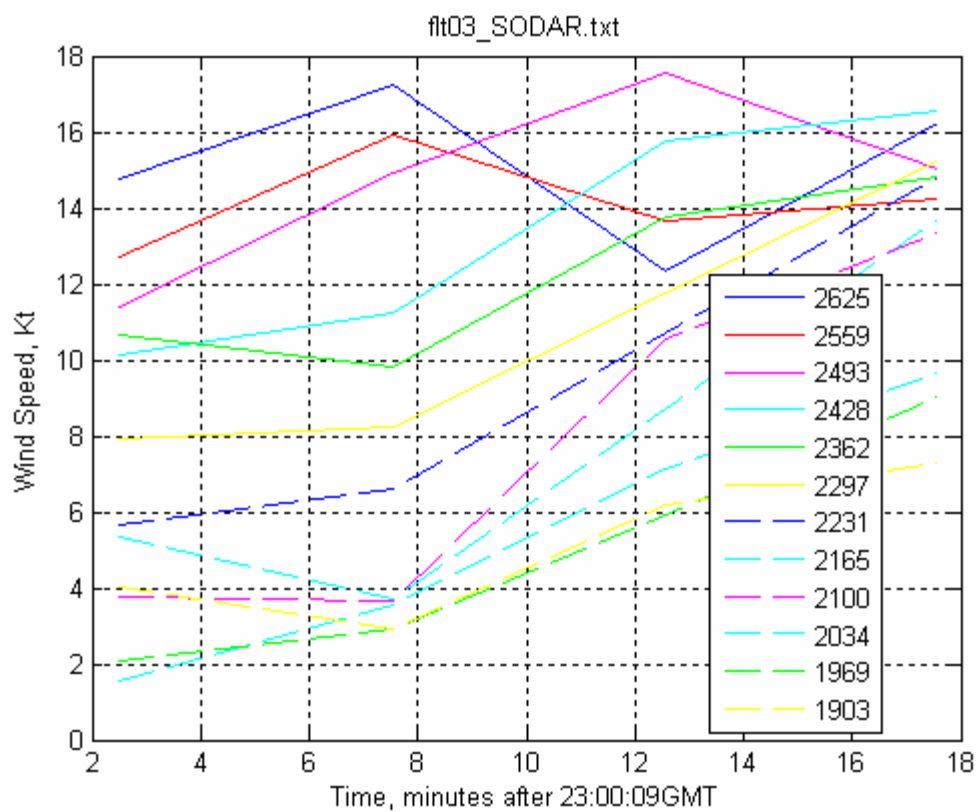
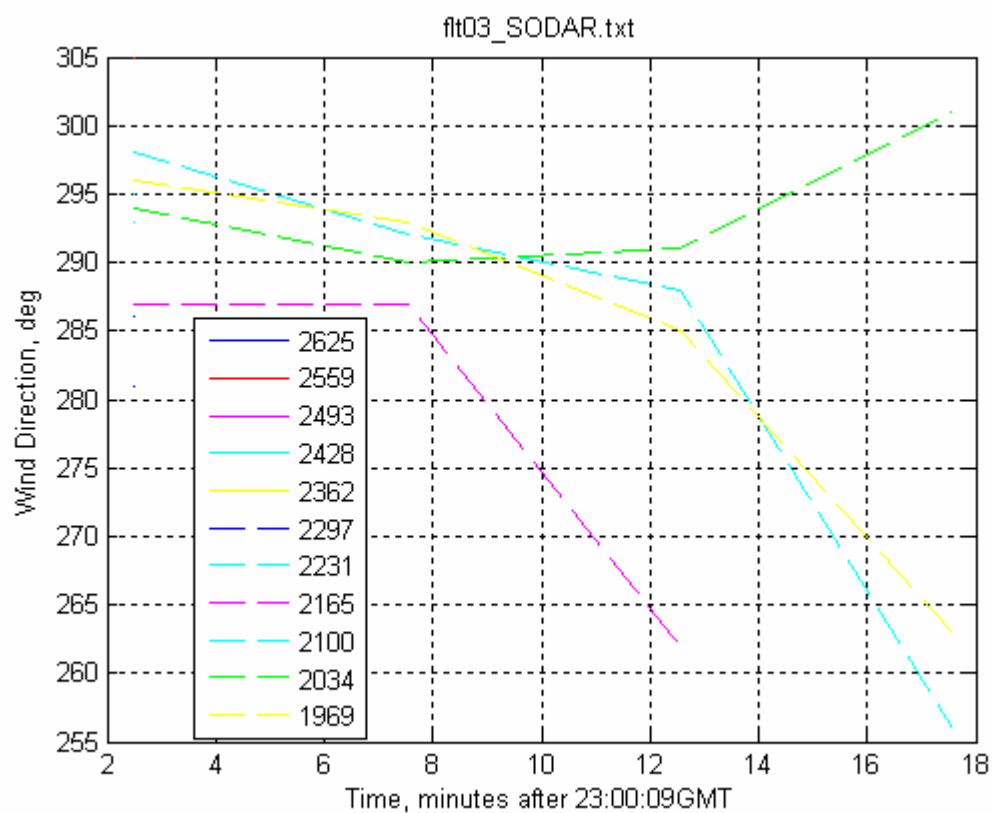
1.6.10 SODAR Data

SODAR Data for flight 3 was taken near the shuttle area, approximately 2 miles away. Sodar data starts at 12/14/2006 23:00:09. Data is reported in 5 minute averages.
